Coolant Leak From Rear of Engine - Water Outlet Pipe Joint Misalignment

Service Category Engine/Hybrid System

Section Cooling **Market** USA and Mexico

YEAR(S)	MODEL(S)	ADDITIONAL INFORMATION
2022	Tacoma

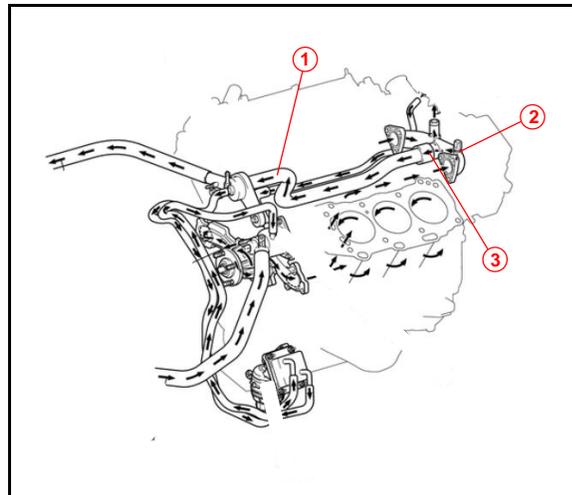
Figure 1.

Some 2022 model year Tacoma vehicles may exhibit a coolant leak, coolant dripping onto the ground, or high engine coolant temperature. The coolant leak may occur from the rear of the engine and drip down the transmission bell housing. Upon further inspection, coolant may be leaking from the union between the Rear Water By-Pass Joint and the No.1 Water Outlet Pipe (see Figure 1). Follow the Repair Procedure in this bulletin to address this condition.

1	No. 1 Water Outlet Pipe
2	Rear Water By-pass
3	Leak Point

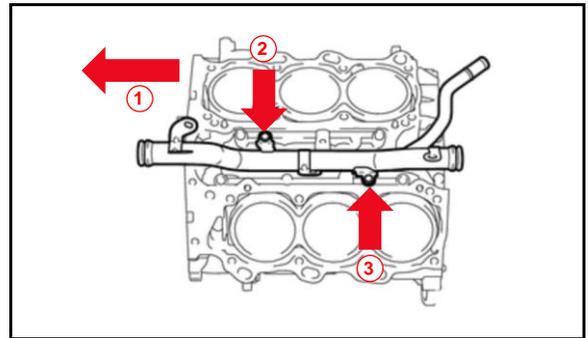
Figure 3.

1	Front
2	No. 1 (Front) Bolt
3	No. 2 (Rear) Bolt

3. Remove the two bolts that hold the water outlet tube assembly to the block.

NOTE
A magnetic socket is useful when removing the bolts to prevent them from being dropped

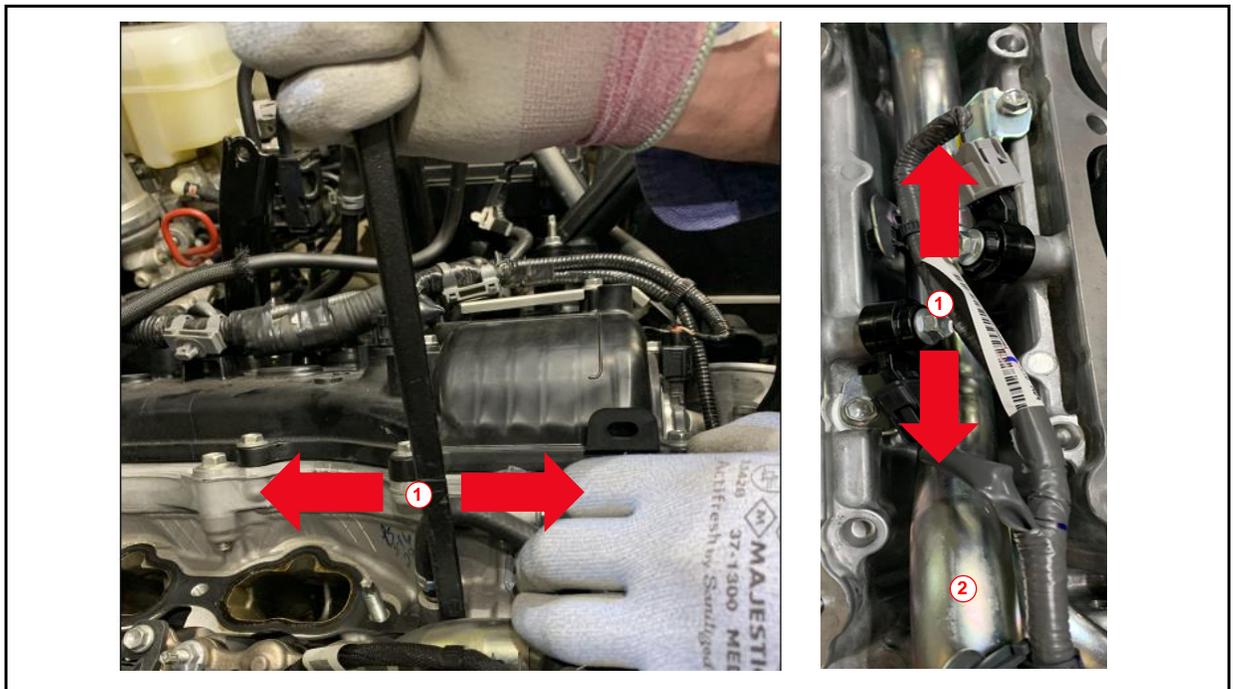
Figure 4.

- This back-and-forth motion effectively allows the heater pipe to find its natural alignment to the water joint openings and reseats the O-rings simultaneously.
- The O-ring is **NOT** able to be inspected using this method. O-ring damage is not likely to occur as a result of joint misalignment.

1	Move Heater Pipe in Front/Rear Direction 3 – 4 times and Retighten
2	Outlet Pipe

4. Reposition the water outlet pipe for proper alignment to the water joints:

Using a large screwdriver or by hand, move the water outlet pipe assembly back and forth (toward the bulkhead, then toward the front of the vehicle, and then again toward the bulkhead).

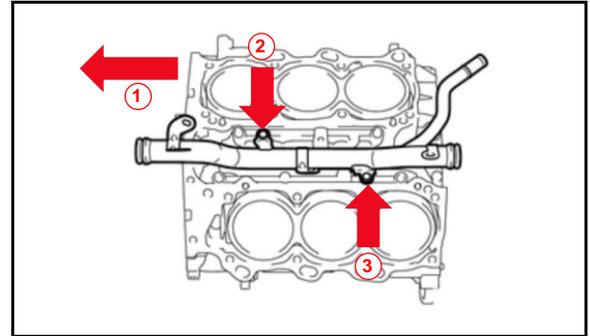
Figure 5.

1	Front
2	No. 1 (Front) Bolt
3	No. 2 (Rear) Bolt

5. Install the two outlet pipe bolts and torque to specification (7 ft./lb.).

Start with the No. 1 (front) bolt, and then move to the No. 2 (rear) bolt.
