Technical Service BULLETIN

WATER LEAK FIELD-FIX REPAIR INSTRUCTIONS

'97 – '04 Tacoma

REVISÉD
BODY
BO026-00

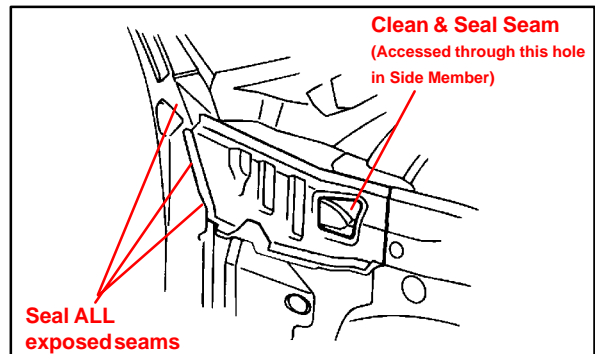
If seam is not sealed properly, clean vertical and horizontal seam area with Acrysol™ cleaner. Use an air hose to dry all seams before applying sealer.

14. Using a flashlight, look through the 2" x 3" rectangular hole on side of vertical cowl panel and locate vertical seam that connects side of cowl to front cowl.

Hole is located behind fender.

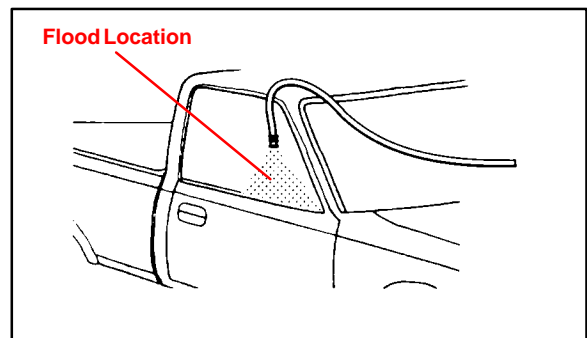
If there are voids/skips between the plastic sheet and the door panel, it will need to be resealed.

- A. Using a heat gun, heat the butyl tape securing the plastic sheet to make removal easier.
- B. Use Kent Acrysol to clean the door panel and plastic sheet.
