Sloshing or Splashing Noise From Inside One or More Door Panels

Service Category Vehicle Exterior

Section Door/Hatch

YEAR(S)	MODEL(S)	ADDITIONAL INFORMATION
2021 - 2022	RAV4 Prime	
2019 - 2022	RAV4, RAV4 HV

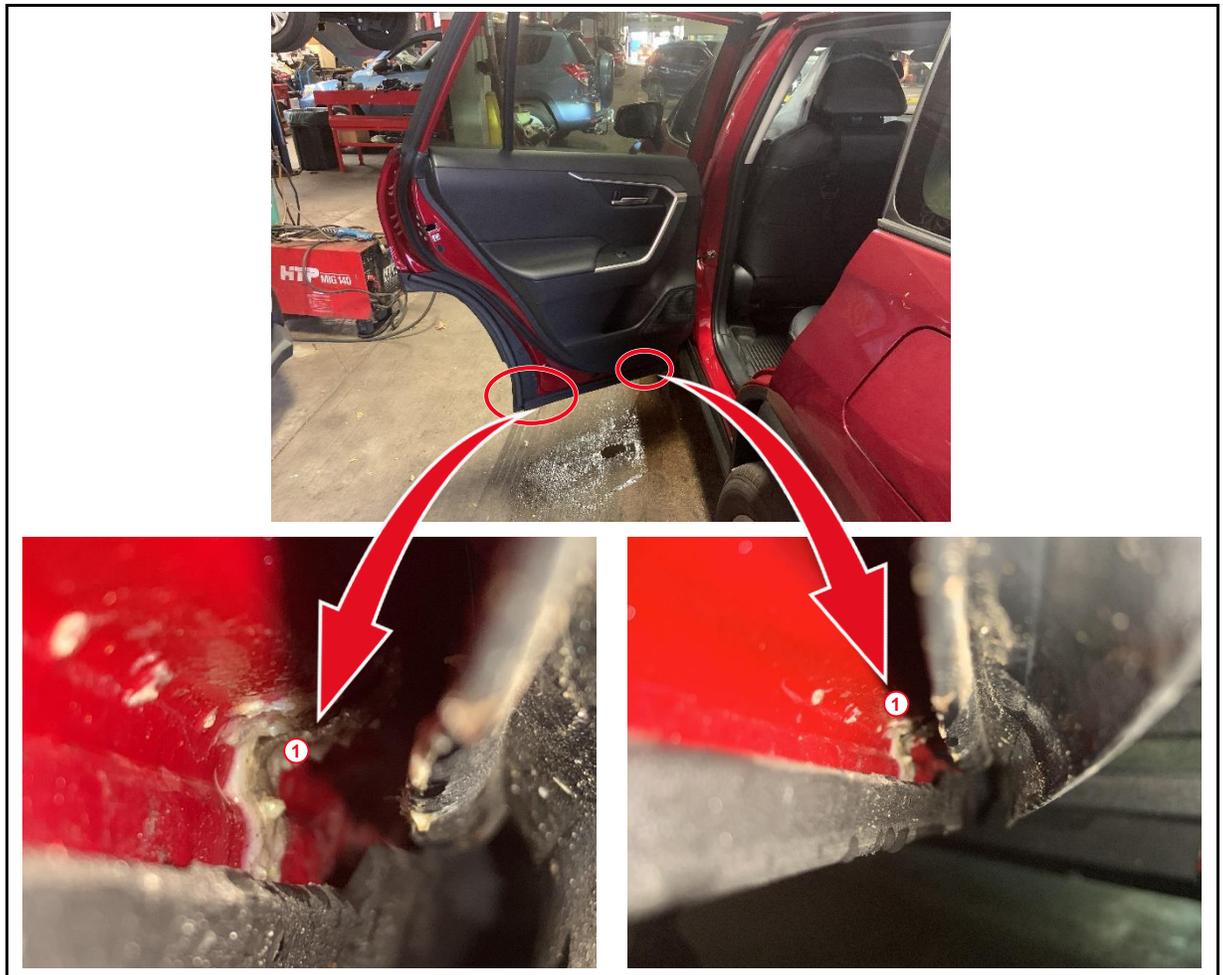
Figure 1.

Is there excessive cavity wax/debris/substance blocking the door drain holes and restricting water from draining properly?

1	Wax-type Substance Blocking the Door Drain Holes
----------	---

3. Remove the bottom door weatherstrip molding from ALL four doors (front left, front right, rear left, and rear right).
 - A. Use the plastic clip removal tool to disengage the clips from the front doors and remove the front door No. 2 weatherstrip molding.
 - B. Use the plastic clip removal tool to disengage the clips from the rear doors and remove the rear door No. 5 weatherstrip molding.

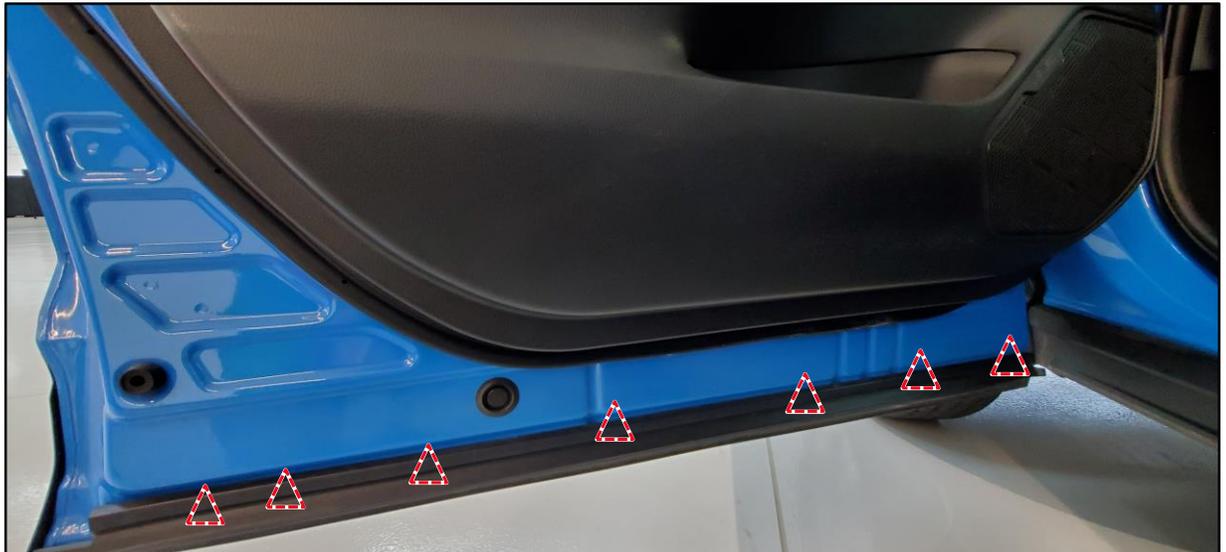
Figure 2.

Location of Clips Behind the Weatherstrip Molding

Replace weatherstrip molding if the clips are damaged during removal.

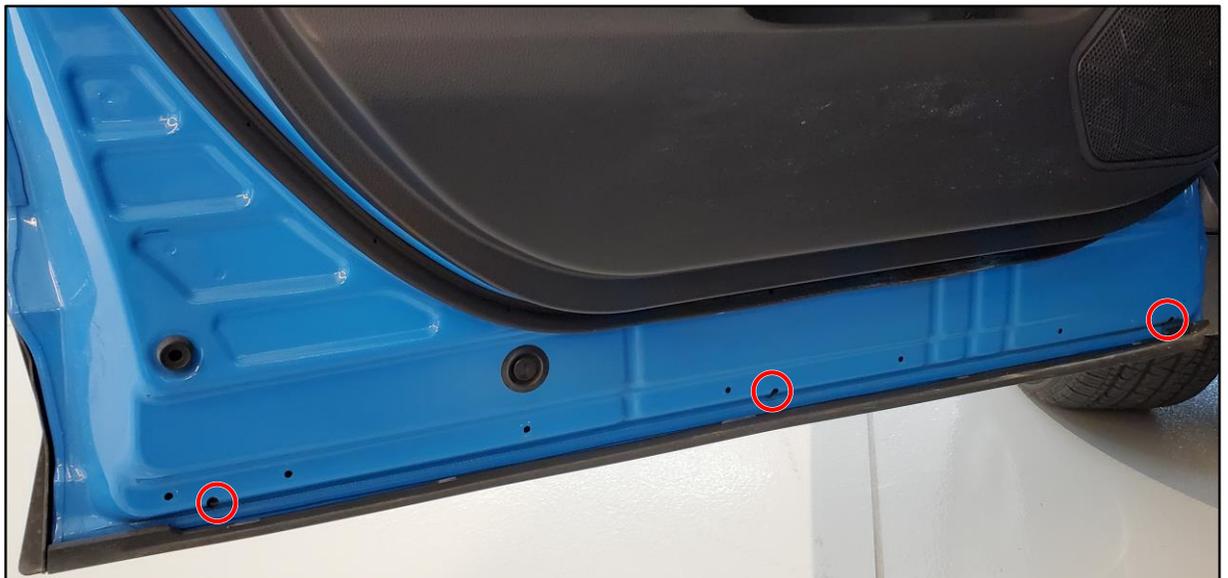
Figure 3.

Location of Drain Holes
--	-------------------------

- Use high pressure water to clean ALL debris from the weatherstrip moldings and drain holes from ALL four doors.

Make sure all weatherstrip moldings and drain holes on all doors are clean and free of road debris.

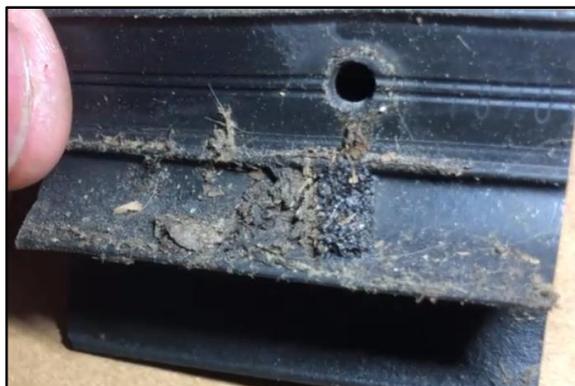
Figure 4. Example of Debris on Weatherstrip Molding

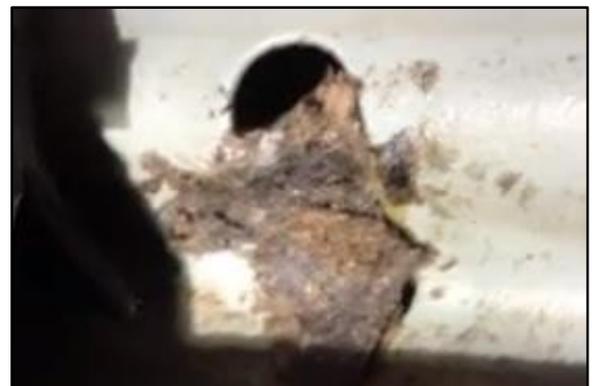
Figure 5. Example of Debris on Drain Hole

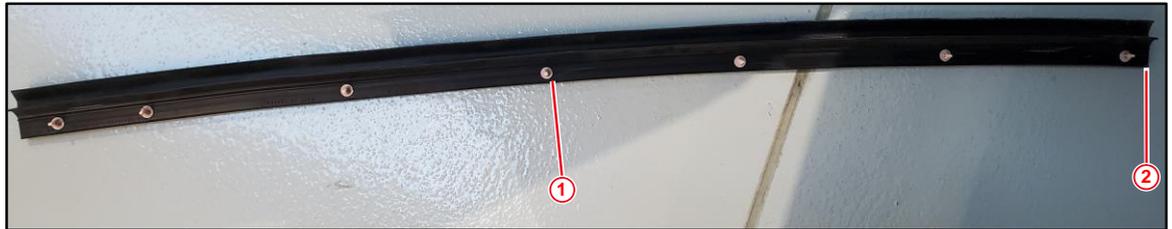
Figure 6. Weatherstrip Molding

1	Clip No. 4
2	Rear Edge of the Molding

5. BEFORE reinstalling the front door weatherstrip moldings trim the inner lip of the weatherstrip moldings for ALL front doors to prevent debris buildup in the future.
 - A. Measure 27 mm from clip No. 4 from the rear edge of the molding (right).

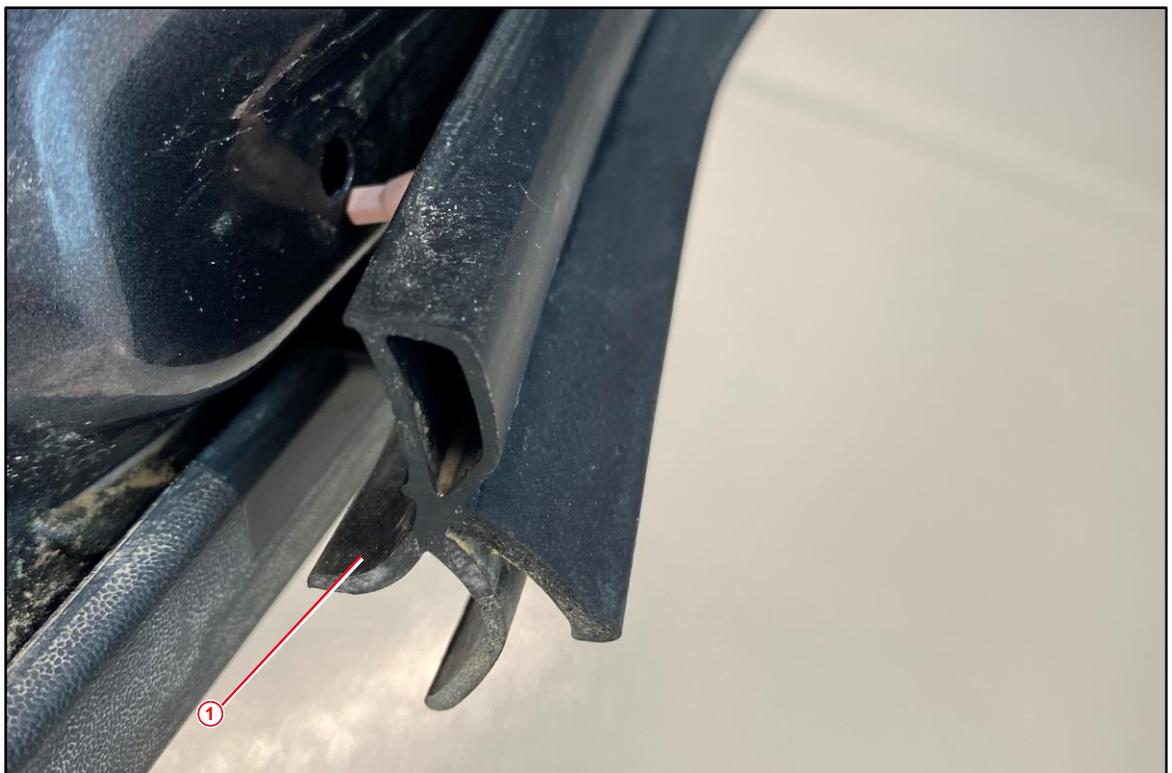
Figure 7. Weatherstrip Molding

1	Inner Lip
----------	-----------

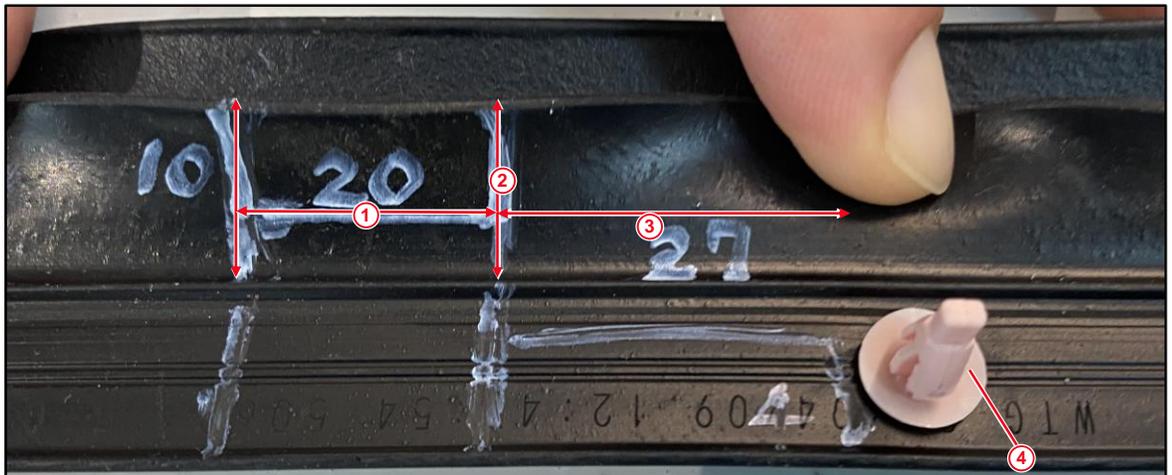
Figure 8. Weatherstrip Molding

1	Length of Cut: 20 mm
2	Height of Cut: 10 mm
3	Length Between Cut and Clip No. 4: 27 mm
4	Clip No. 4 (from rear edge of the molding)

B. Cut the inner lip of the weatherstrip molding with the following dimensions:

Length: 20 mm

Height: 10 mm

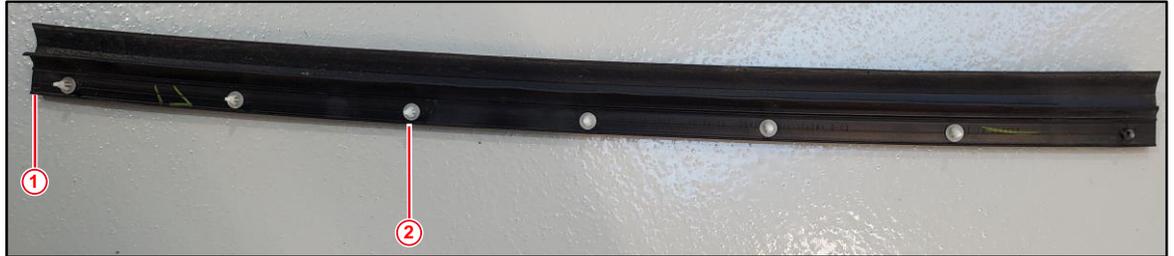
Figure 9. Weatherstrip Molding

1	Front Edge of the Molding
2	Clip No. 3

6. BEFORE reinstalling the rear door weatherstrip moldings, trim the inner lip of the weatherstrip moldings for ALL rear doors to prevent debris build up in the future.
 - A. Measure 37 mm from clip No. 3 from the front edge of the molding (left).

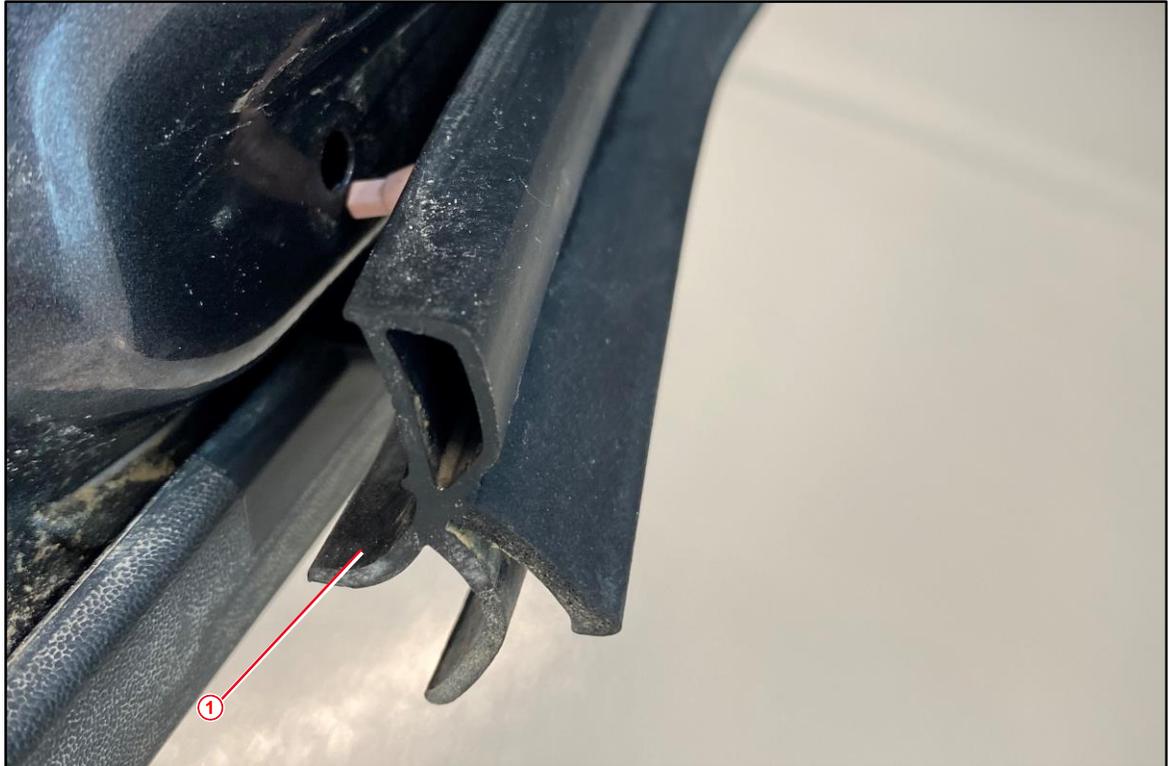
Figure 10. Weatherstrip Molding

1	Inner Lip
----------	------------------

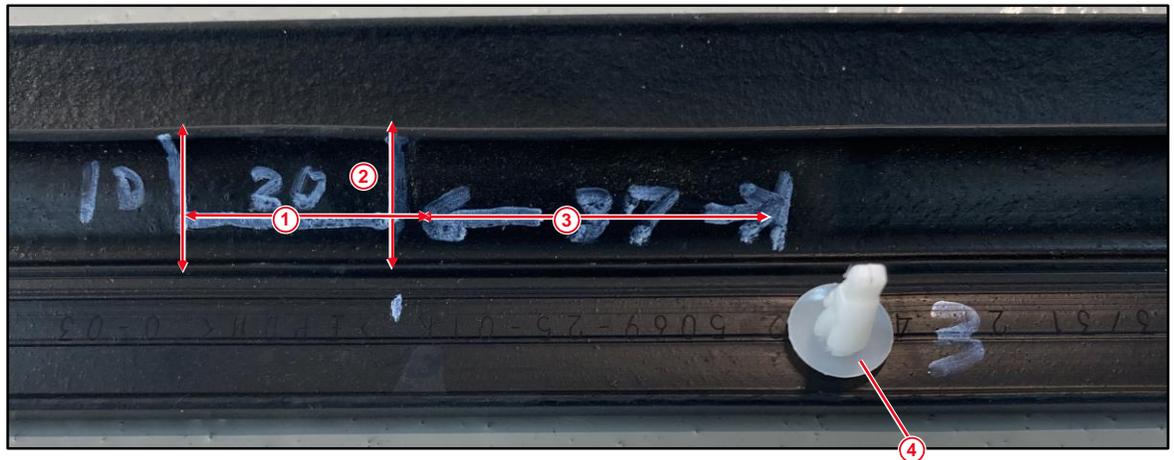
Figure 11. Weatherstrip Molding

1	Length of Cut: 20 mm
2	Height of Cut: 10 mm
3	Length Between Cut and Clip No. 3: 37 mm
4	Clip No. 4

B. Cut the inner lip of the weatherstrip molding with the following dimensions:

Length: 20 mm

Height: 10 mm

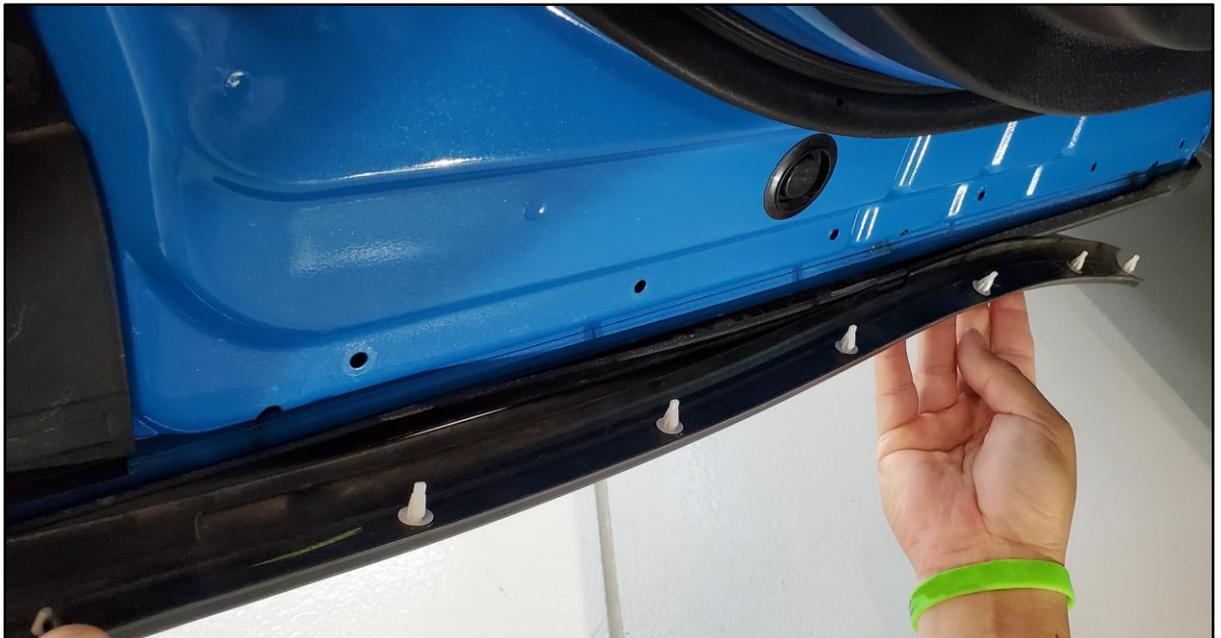
Figure 12. Reinstalling Weatherstrip Molding to Door

7. Reinstall the weatherstrip molding back on ALL doors.
 - A. Reinstall the front door No. 2 weatherstrip moldings by reinstalling the clips.
 - B. Reinstall the rear door No. 5 weatherstrip moldings by reinstalling the clips.

Replace weatherstrip molding if the clips are damaged during removal.

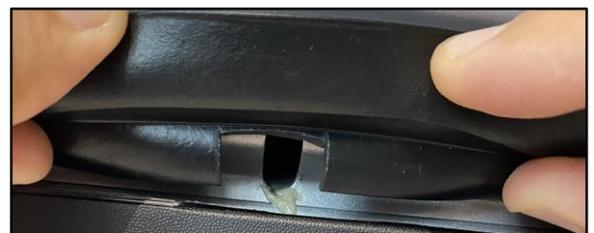
Figure 13.

8. Ensure the cut window on the weatherstrip molding and the drain hole align properly.

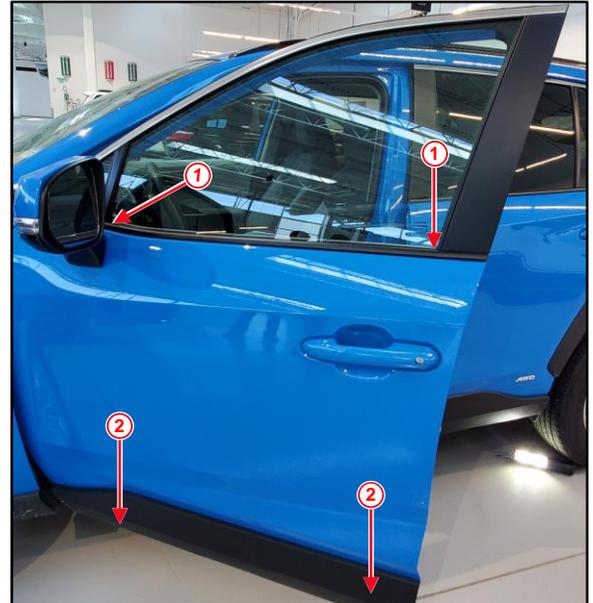
Figure 14.

1	Pour Water Here
2	Check Water Drain

9. Pour water into the repaired doors to confirm the drain holes are working properly.

10. Open and close the repaired doors and test-drive the vehicle to ensure the condition no longer exists.
