# MIL "ON" DTC P0A80 Due to Dust or Debris in HV Battery Cooling Fan

**Service Category** Engine/Hybrid System

**Section** Hybrid/Battery Control System

YEAR(S)	MODEL(S)	ADDITIONAL INFORMATION
2013 – 2015	Prius

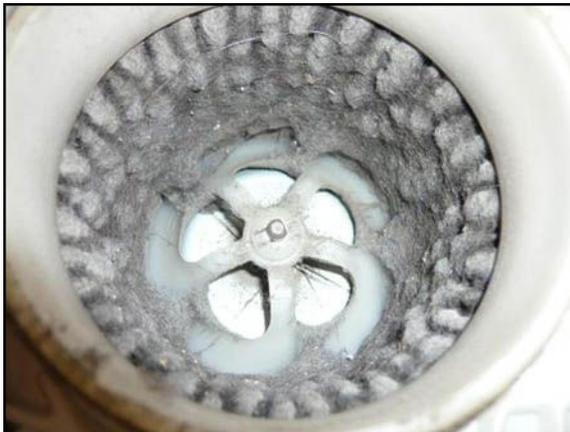
Is the HV Battery Cooling Fan clogged with dust or debris buildup? Refer to Figure 1 for an example of a clogged cooling fan.

**Figure 1. HV Battery Cooling Fan BEFORE Cleaning**

2. Using vacuum, and compressed air, if necessary, clean any dust, lint, or debris buildup from the HV Battery Cooling Fan blades, module, and ducts.

- Do NOT attempt to clean the HV Battery Cooling Fan while it is installed in the vehicle. Doing so may cause dust or debris to enter the HV Battery Case.
- Failure to secure the fan blades while cleaning can result in electronic circuit failure due to overturning.

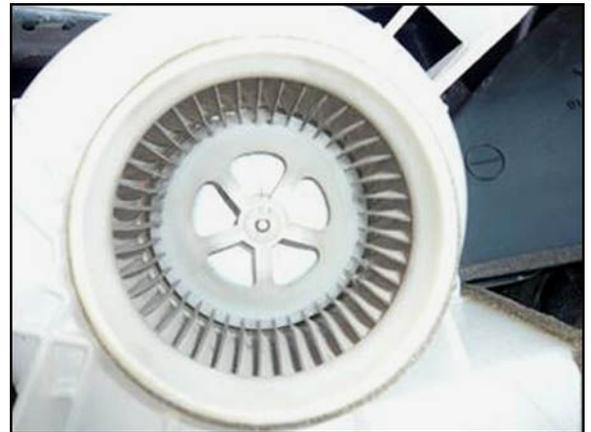
**Figure 2. HV Battery Cooling Fan AFTER Cleaning**

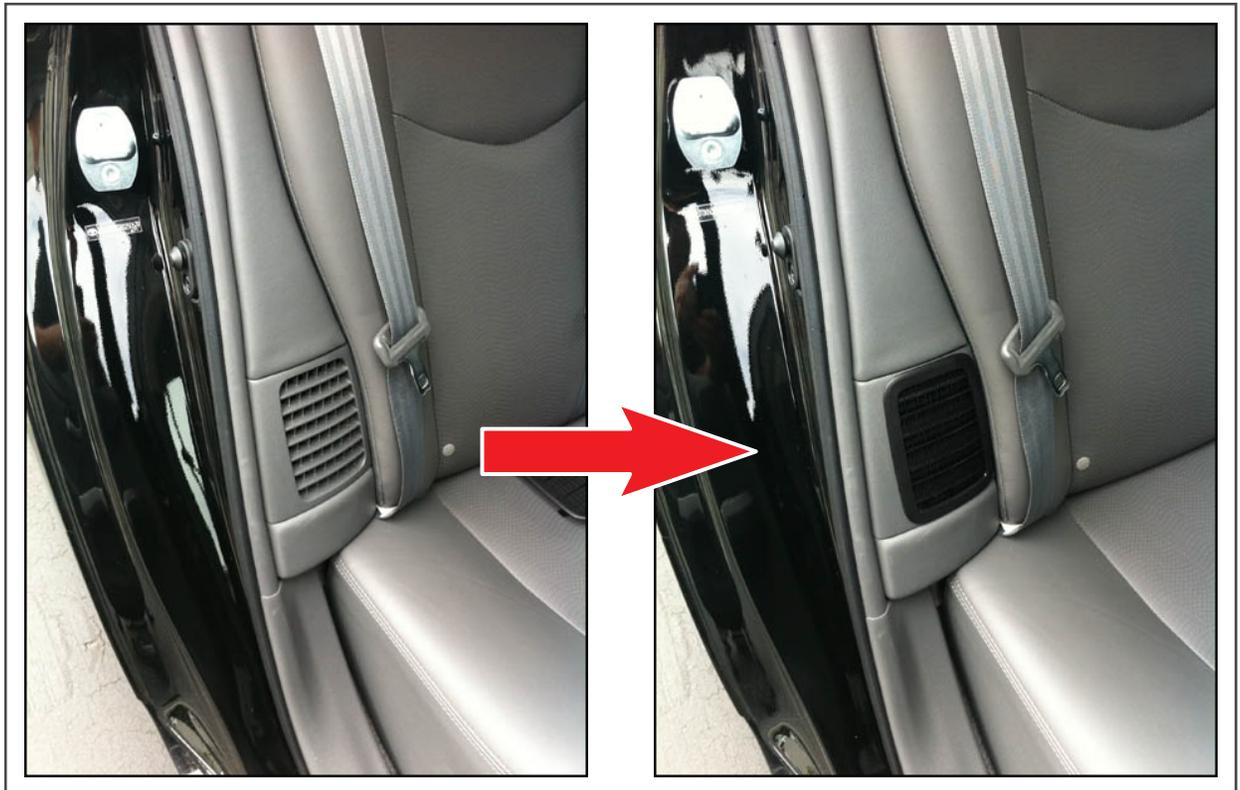
Figure 3.

4. Install the HV Battery Cooling Fan Intake Filter as shown (P/N G92DH-47010).

The filter should be cleaned when dust begins to appear on the surface.

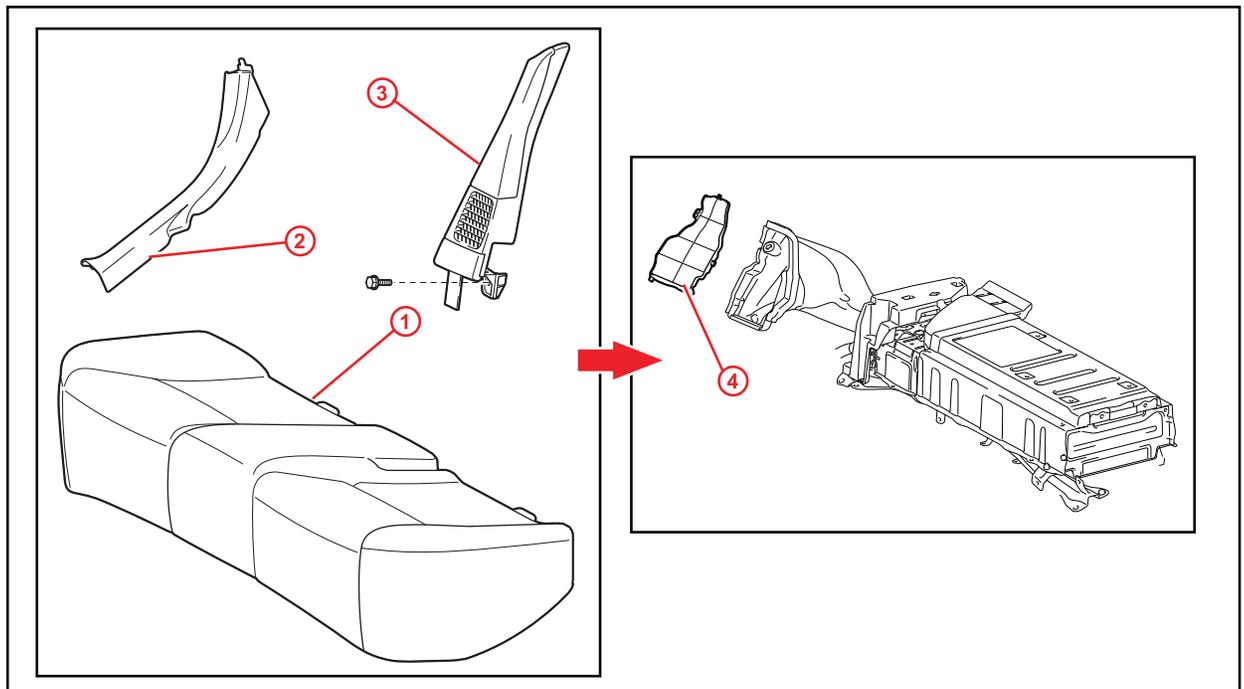
Figure 4.

1. Is the internal filter clogged with dust or debris buildup?

<b>1</b>	Rear Seat Cushion Assembly
<b>2</b>	Rear Door Scuff Plate RH

<b>3</b>	Rear Side Seat Back Assembly RH
<b>4</b>	Hybrid Battery Intake Filter

The seat back does NOT need to be removed even though it's not shown in the Figure above.

2. Check the physical condition of the internal filter.
  - A. If the filter is damaged, replace the HV Battery Intake Filter No. 1 (P/N G92DH-47060).
  - B. If the filter is physically OK, clean using vacuum and make sure no contaminants enter the HV Battery cooling system including fan.

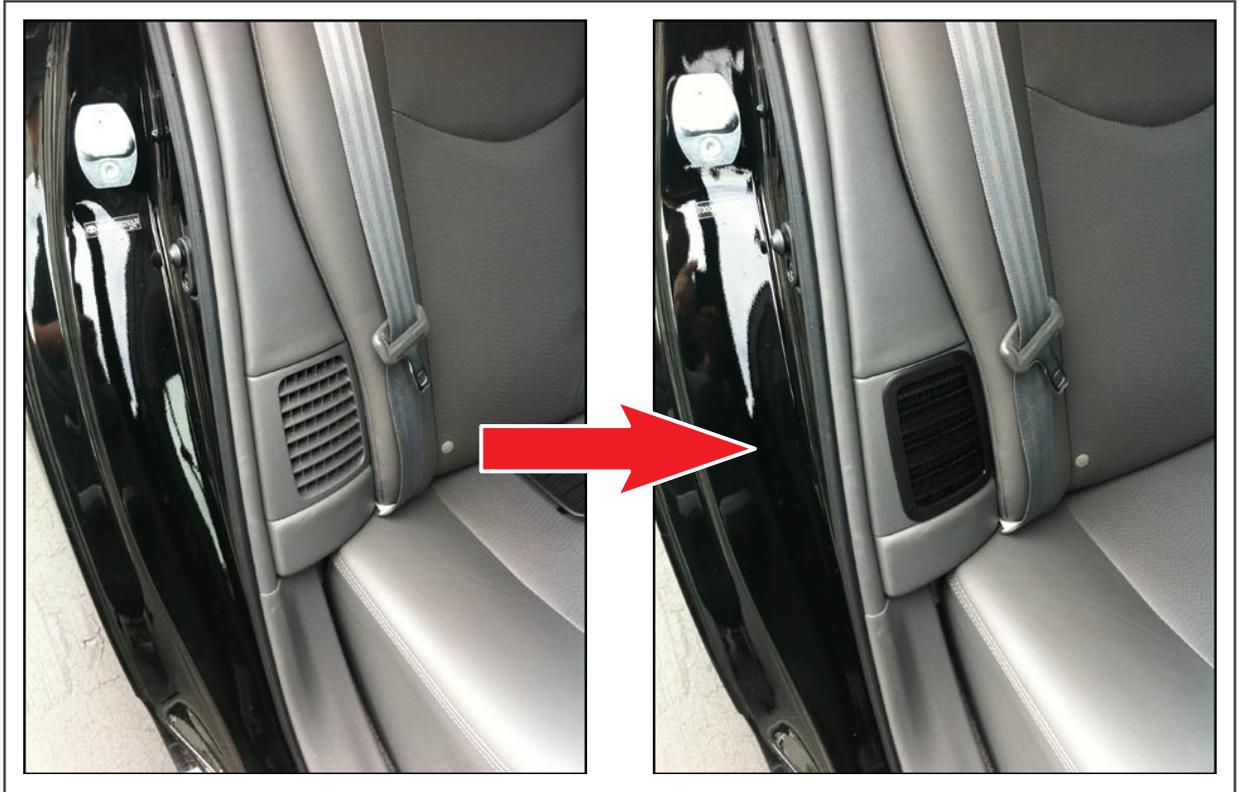
Figure 5.

3. Install the HV Battery Cooling Fan Intake Filter as shown (P/N G92DH-47010).

The filter should be cleaned when dust begins to appear on the surface.
